EPA R6 Dive Team Operations Report

San Jacinto Waste Pits
Channelview, TX
December 9-10, 2015

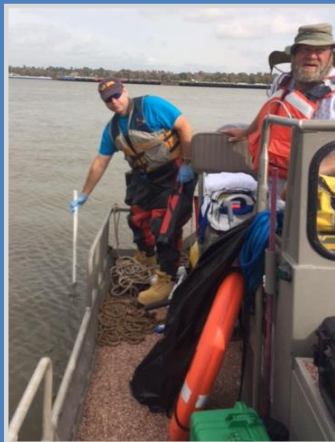
Based on the 4 coordinates and additional probing, the suspected area of deficiency is approximately XXsq.ft. After penetrating multiple feet into the sediment, the white plastic pole was covered with a thick, grey, sludge-like material when brought to the surface (Image 1, Image 2, and Image 3). This material is not similar in nature to the flocculent sediment identified at other areas of the cap.

Image 1:
Insertion of probe adjacent to location A.1 where rock is not present.

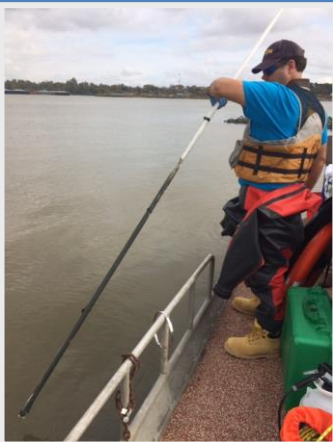
Image 2:
Probe brought to the surface after sediment penetration adjacent to location A.1.

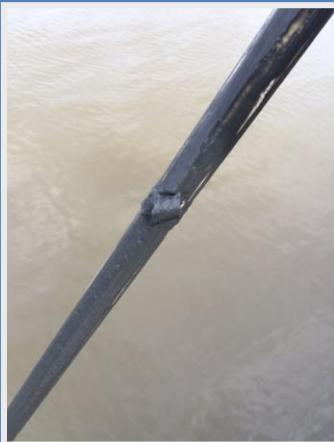
Image 3:
Thick, grey, sludge-like material on probe after sediment penetration adjacent to A.1.

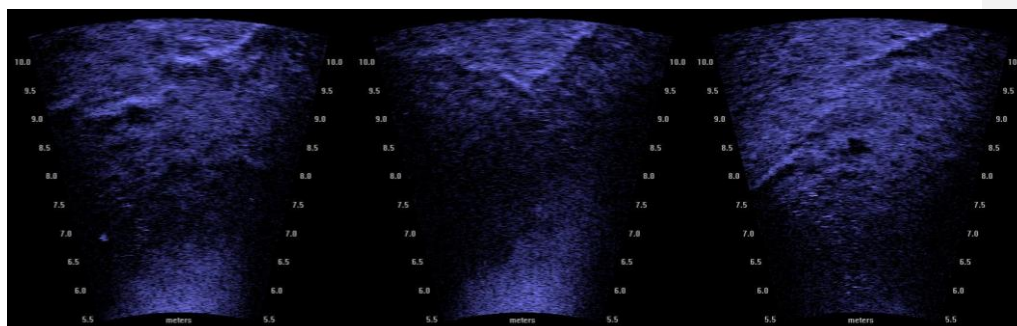
Imaging sonar was utilized in this area in an attempt to visualize the area of deficiency. This area was not identifiable via sonar, but other areas of interest were identified based on changes in color within the sonar image (Image 4 and Map). A tethered diver was used to physically inspect these areas. Rock was found to be present throughout these areas. Two factors introduced difficulty during sonar operation. The clarity of the sonar imagery was negatively influenced by wind. Wind-driven movement of the boat distorted sonar imagery. Usefulness of the sonar was limited to areas that were covered with little to no sediment. This condition existed in areas of the cap with sloping bathymetry.

Image 4: Sonar Images of armored cap.
